## MEMORANDUM

Purpose: CERCLA Screening Site Inspection

Site: Swift Adhesives and Coatings  
2847 Awaawaloa Street  
Honolulu, Hawaii 96819  
Honolulu County

## Field Investigation Team Zone II

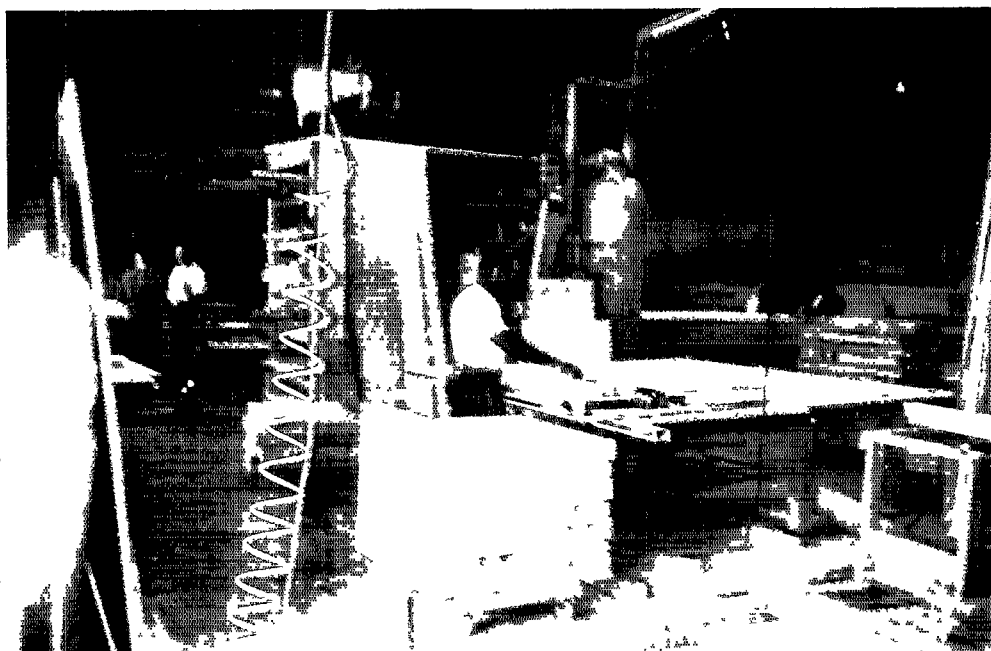
Current woodworking operations. Only sawdust waste generated.

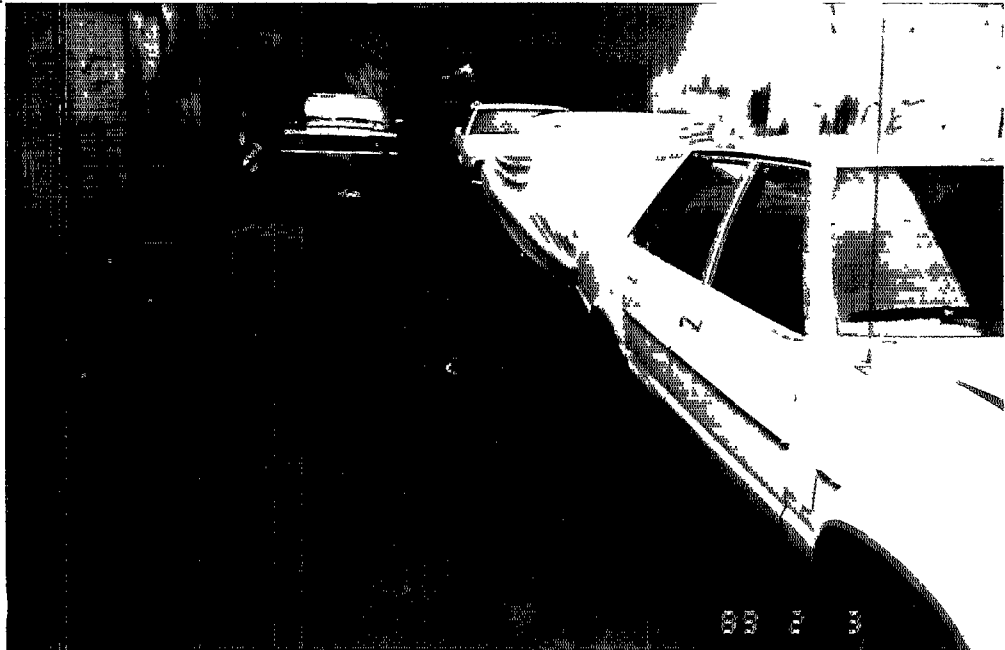
Paved side lot. Note storm drain opening.
